## **Positive Unintended Consequences How Campbell Lake Gravity Sewer Pipeline Line Survived a Magnitude 7.1 Earthquake**

**David Persinger, P.E.,<sup>1</sup> Maury D. Gaston<sup>2</sup>**

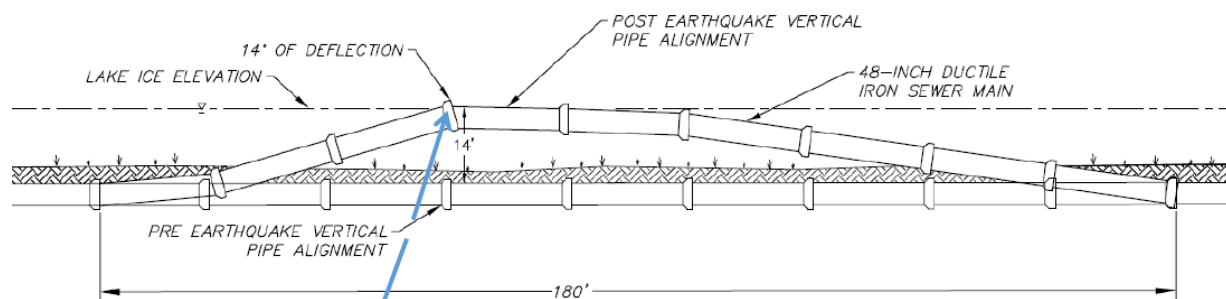
The crown of the line was 14 feet below the surface of the lake, and when the quake occurred, the lake had an ice surface 16-inches thick. A section of the line 180 feet in length deflected and rose to the surface without separating, at which point the 16-inch thick ice held it in place. Figure 2 shows the profile of this post-quake deflection (Willie B. O'Malley 2019).

Figure 2. Post-quake profile of the deflected pipe joints held in place by the 16-inch thick ice surface 14-feet above the crown of the pipe (Willie B. O'Malley 2019).

Calculated joint deflections of the profile vary to a maximum of 14-degrees for the joint at Sta 68+00, the joint pressing under the ice.

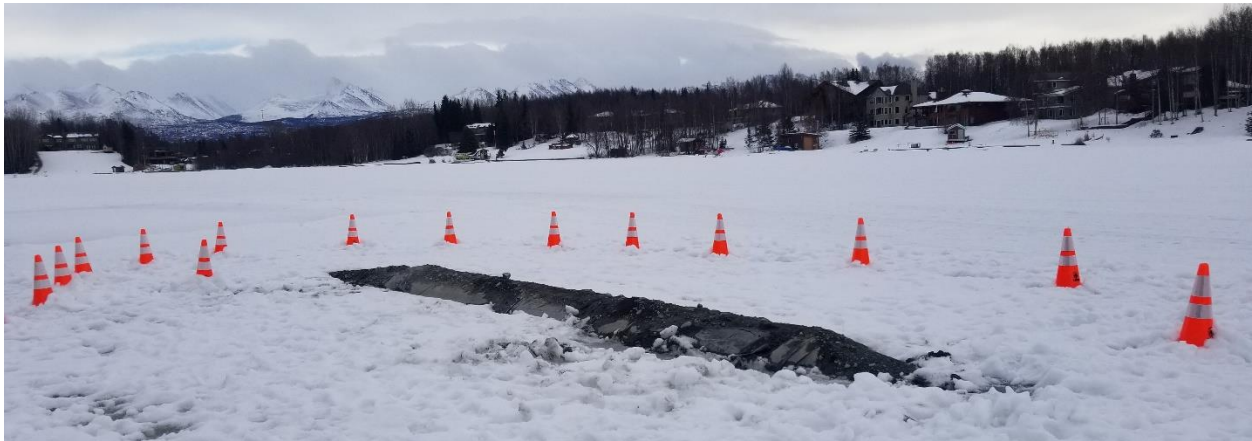
On March 14, 2019, 104 days after the event, the ice had melted enough that buoyant forces exposed the dislocated ductile iron piping. A photograph of the highest-elevated joints rising through the ice resembling a surfacing submarine is shown in Figure 3.

Figure 3. The highest-elevated joints rising through the ice on March 14, 2019, 104 days after the event.

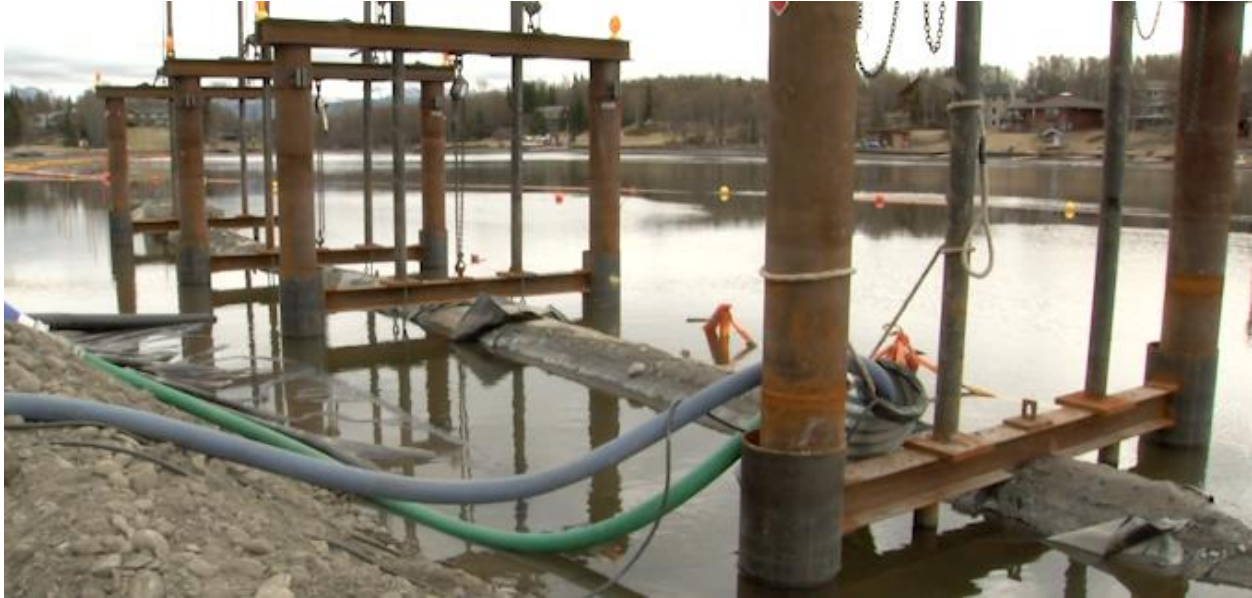
Figure 4. A stabilizing assembly driven into the lakebed to hold the ductile iron piping in place after the ice had melted.

A stabilizing assembly was quickly designed and constructed, driven into the lakebed, and assembled over the trunk line to prevent it from further flotation, likely joint separation, and sewage spill. (Lauren Maxwell 2019) This structure is shown in Figure 4.

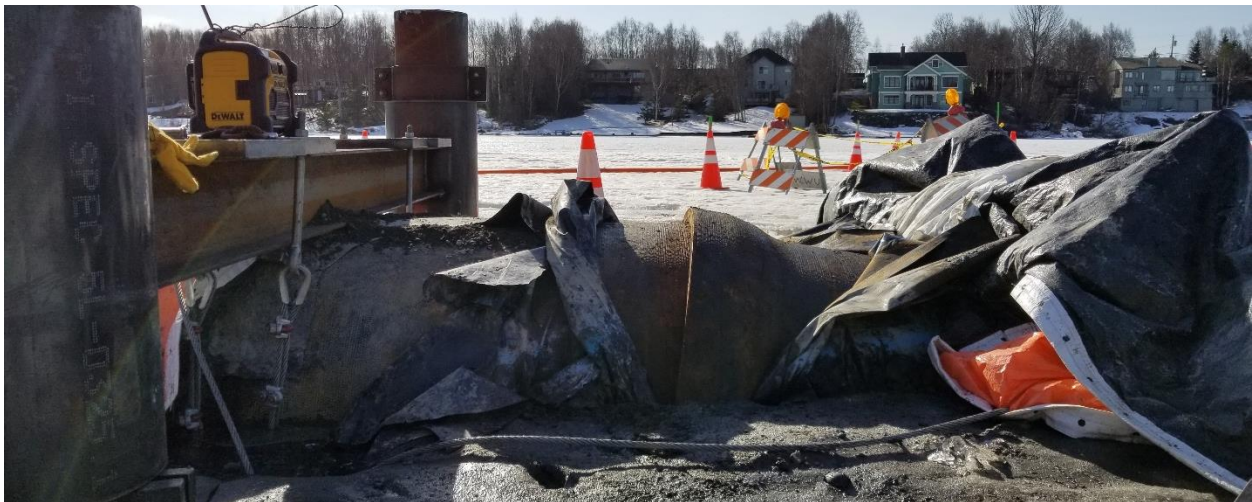
The most severely deflected joint in the post-quake assembly was at Sta 68+00, the joint against the ice shown in Figure 2. It was calculated to be deflected to 14-degrees, well beyond its rated special deflection of 4-degrees. This joint is shown as a photograph in Figure 5 in full exposure following complete ice melt. Notice the significant length of spigot that has spent 30 years inside the bell protected with traditional polyethylene encasement. The resilience of this joint to perform in such a manner is remarkable and will be discussed later in this paper.

Figure 5. A Fastite push-on joint ductile iron pipe deflected at a calculated angle of 14-degrees and maintaining joint performance.

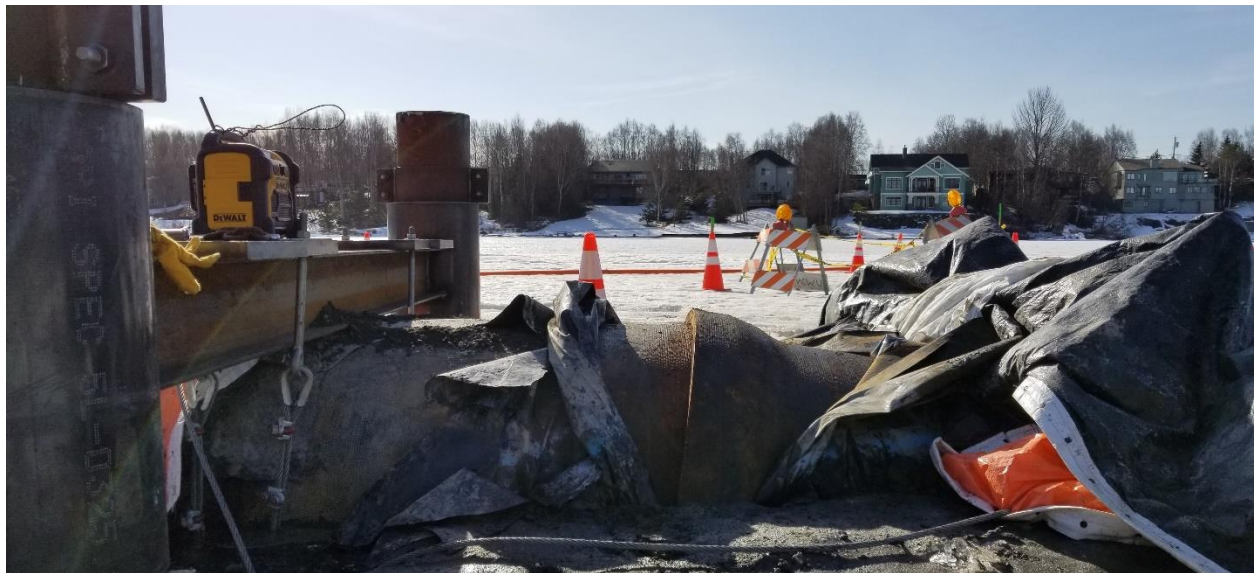
Another item of resilience to note is the condition of the pipe after 29 years in the sediment lakebed of Campbell Lake. The ductile iron pipe had a standard factory applied asphaltic top coat covering its annealing scale; and because of the arduous and critical installation, the pipe was wrapped in a double layer of traditional polyethylene encasement. This is the same encasement that was originally used in Lafourche Parish, Louisiana in 1958 (Cox June 2012) which is also the topic of another presentation at this conference. The wrap is governed by AWWA C105, “Polyethylene Encasement for Ductile-Iron Pipe Systems” and is made of virgin polyethylene material conforming to the requirements of ANSI/ASTM Standard Specification D1248 (American Water Works Association 2011). Figure 9 shows the condition of the wrap, the condition of the peen pattern on the surface of the pipe, and the previously noted excessive deflection of the joint while still performing.

Figure 9. The exposed most-severely deflected joint showing condition of the traditional polyethylene encasement and the peen pattern of the pipe surface after 29 years beneath the lakebed.
