## **Positive Unintended Consequences How Campbell Lake Gravity Sewer Pipeline Line Survived a Magnitude 7.1 Earthquake**

**David Persinger, P.E.,<sup>1</sup> Maury D. Gaston<sup>2</sup>**

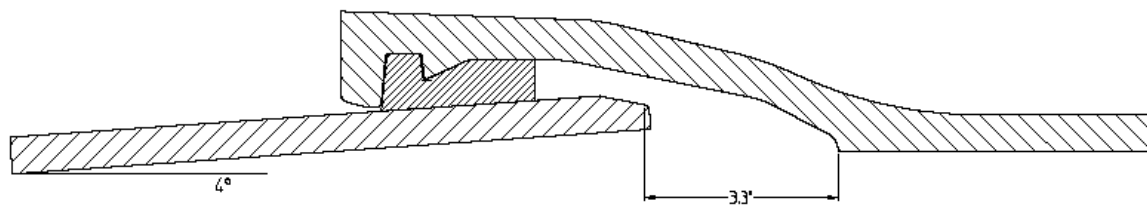
The 48-inch diameter special deflection Fastite joint has a socket depth of 9 inches. In its fully-deflected position of 4-degrees, there is a 3.3 inch joint separation between the end of the spigot and the shoulder inside the bell. A 4-degree special deflection 48-inch diameter Fastite joint is shown in the deflected position in Figure 8.

Figure 8. A 4-degree special deflection 48-inch diameter Fastite joint in the deflected position (American Ductile Iron Pipe 2019).
